## LIFE CYCLE OF THE LAST LNG STORAGE TANK IN FROZEN GROUND

Sonatrach Aval - GL4Z

Arzew - Algeria

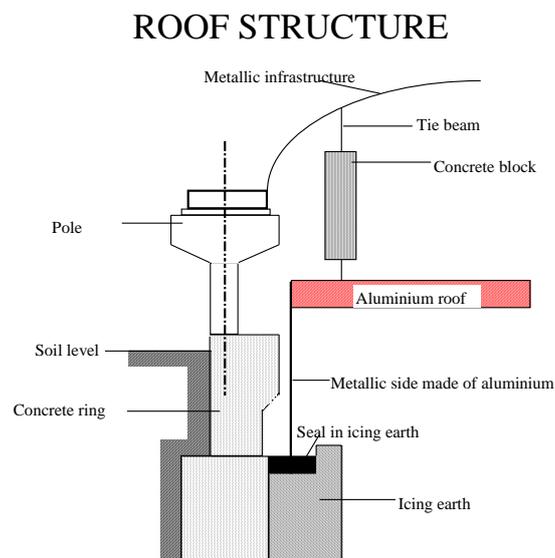
Figure 3: Roof Structure

The damage on the structure of the roof support appears on the following elements:

- *Lining of the pillars:*
  - detachment of the lining leaving the pillars armatures uncovered
  - Vertical cracks and scaling of the lining
  - crumbling of the concrete at its base
- *Pillars:*
  - fissures and bursting on the upper lateral parts at the level of contact with the concrete ring,
  - fissures and detachment of the concrete on the overhead face of the pillars.
- *Slipping plate:*
  - blockage at the level of the contact points of the concrete ring.
- *Metallic slings:*
  - Distortions by buckling

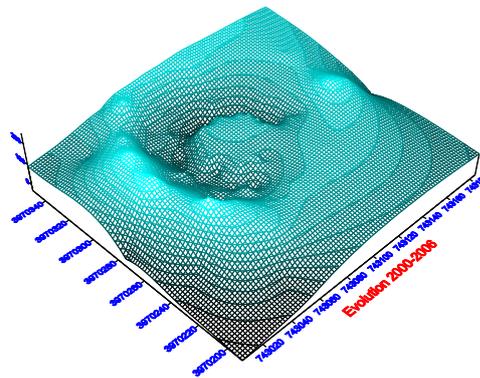
**Figure 5 : Altimétric displacements : 2000-2006**

The comparison of the results of the three GPS campaigns permitted to put in evidence displacements about 129mm in planimetry and 252 mm in altimetry.
