## LIFE CYCLE OF THE LAST LNG STORAGE TANK IN FROZEN GROUND

Sonatrach Aval - GL4Z

Arzew - Algeria

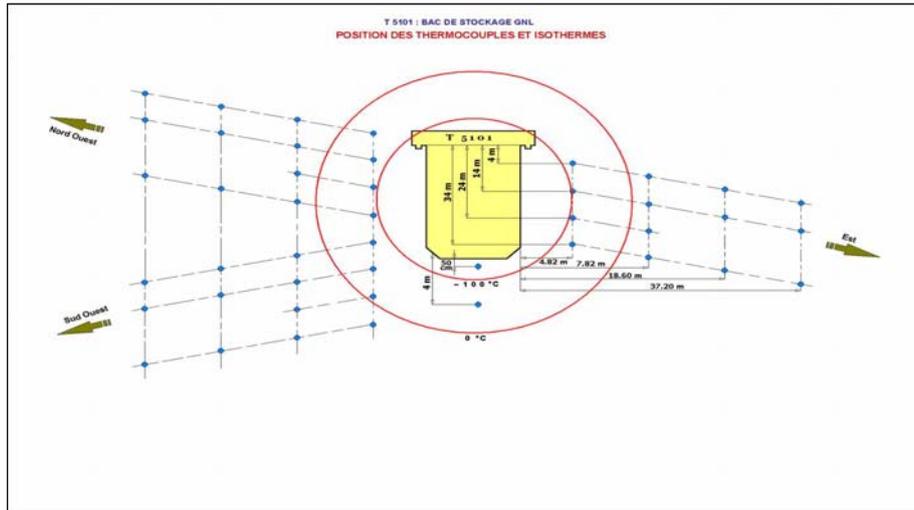
Figure 2: thermocouples arrangement

- Storage environment :
    - The environment of the tank is equipped with 48 thermocouples installed at different depths and distances (16 thermocouples at angles of 120 degrees) to allow control of the ice wall growth by following the isotherms propagation:  $-100\text{C}^{\circ}$ ,  $-50\text{C}^{\circ}$ , and  $0\text{ C}^{\circ}$ .

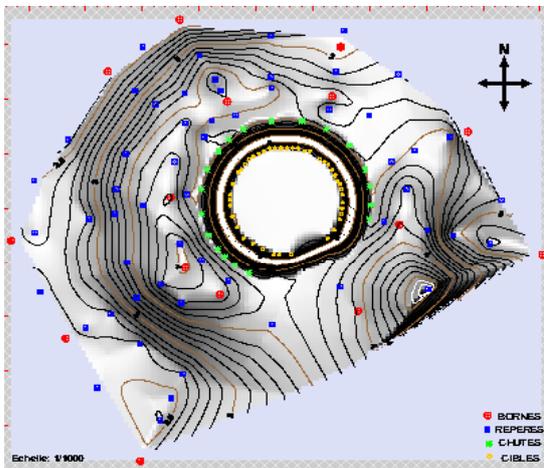
**Figure 4 : Reference configuration (feb. 2000)**

The comparison of the results of the three GPS campaigns permitted to put in evidence displacements about 129mm in planimetry and 252 mm in altimetry.
